Manhole Inspection Summary

Manhole # S49C__034MH

Insp Date: **12/3/08 3:03 PM**

Location Address: **rear 2511 e fayette st**

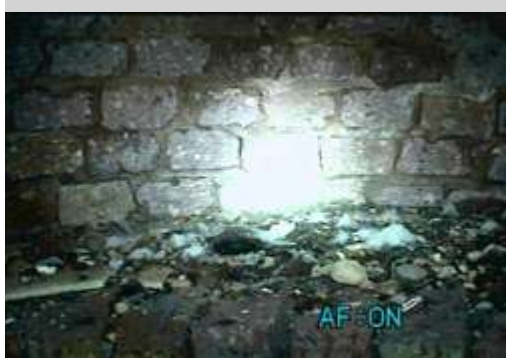
Miscellaneous

bench debris

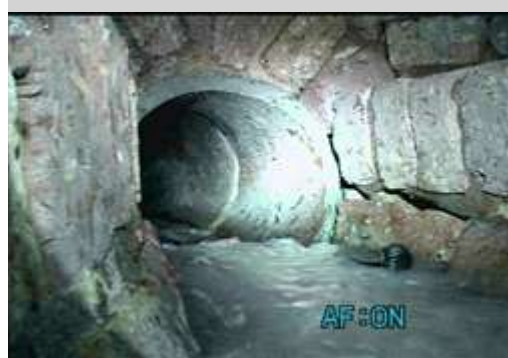
Miscellaneous

channel debris

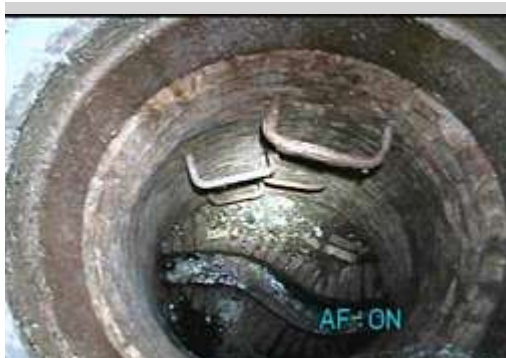
Defect 1

Steps Count: **4** Missing: **0** ☒ Corroded

corr steps

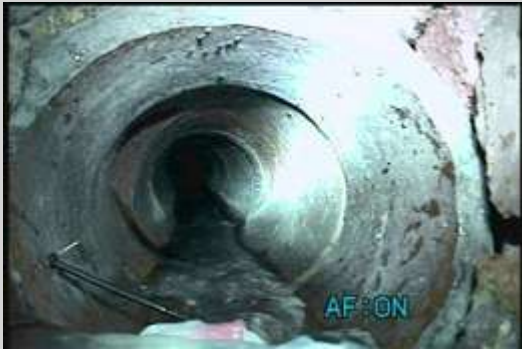
12 O'Clock Outflow

8 in. Circular Gravity Sewer
Pipe Out @ 12 O'Clock

Pipe Material: **Clay** ☐ Pipe Lined

Invert Depth: **8.58** (ft.) Flow Characteristics: **Fast**

Deposits: ☒ None ☐ Mud ☐ Sludge ☐ Debris ☐ Grease

Infiltration: **None** Pipe Seal Cond: **Unknown**

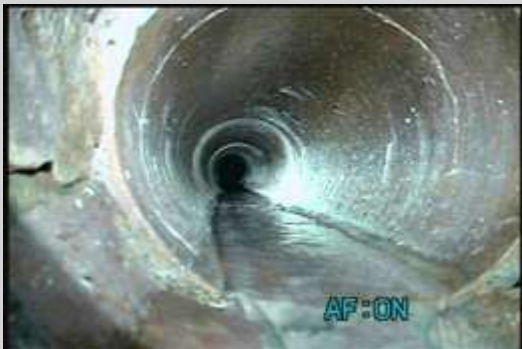
6 O'Clock Inflow

10 in. Circular Gravity Sewer
Pipe In @ 6 O'Clock

Pipe Material: **Clay** ☐ Pipe Lined

Invert Depth: **8.33** (ft.) Flow Characteristics: **Fast**

Deposits: ☒ None ☐ Mud ☐ Sludge ☐ Debris ☐ Grease

Infiltration: **None** Pipe Seal Cond: **Unknown**
